Statement 09/11/10

RE: 210 Woodland Road, Hampton, NH

Home Inspection Report

210 Woodland Ave
Hampton, NH

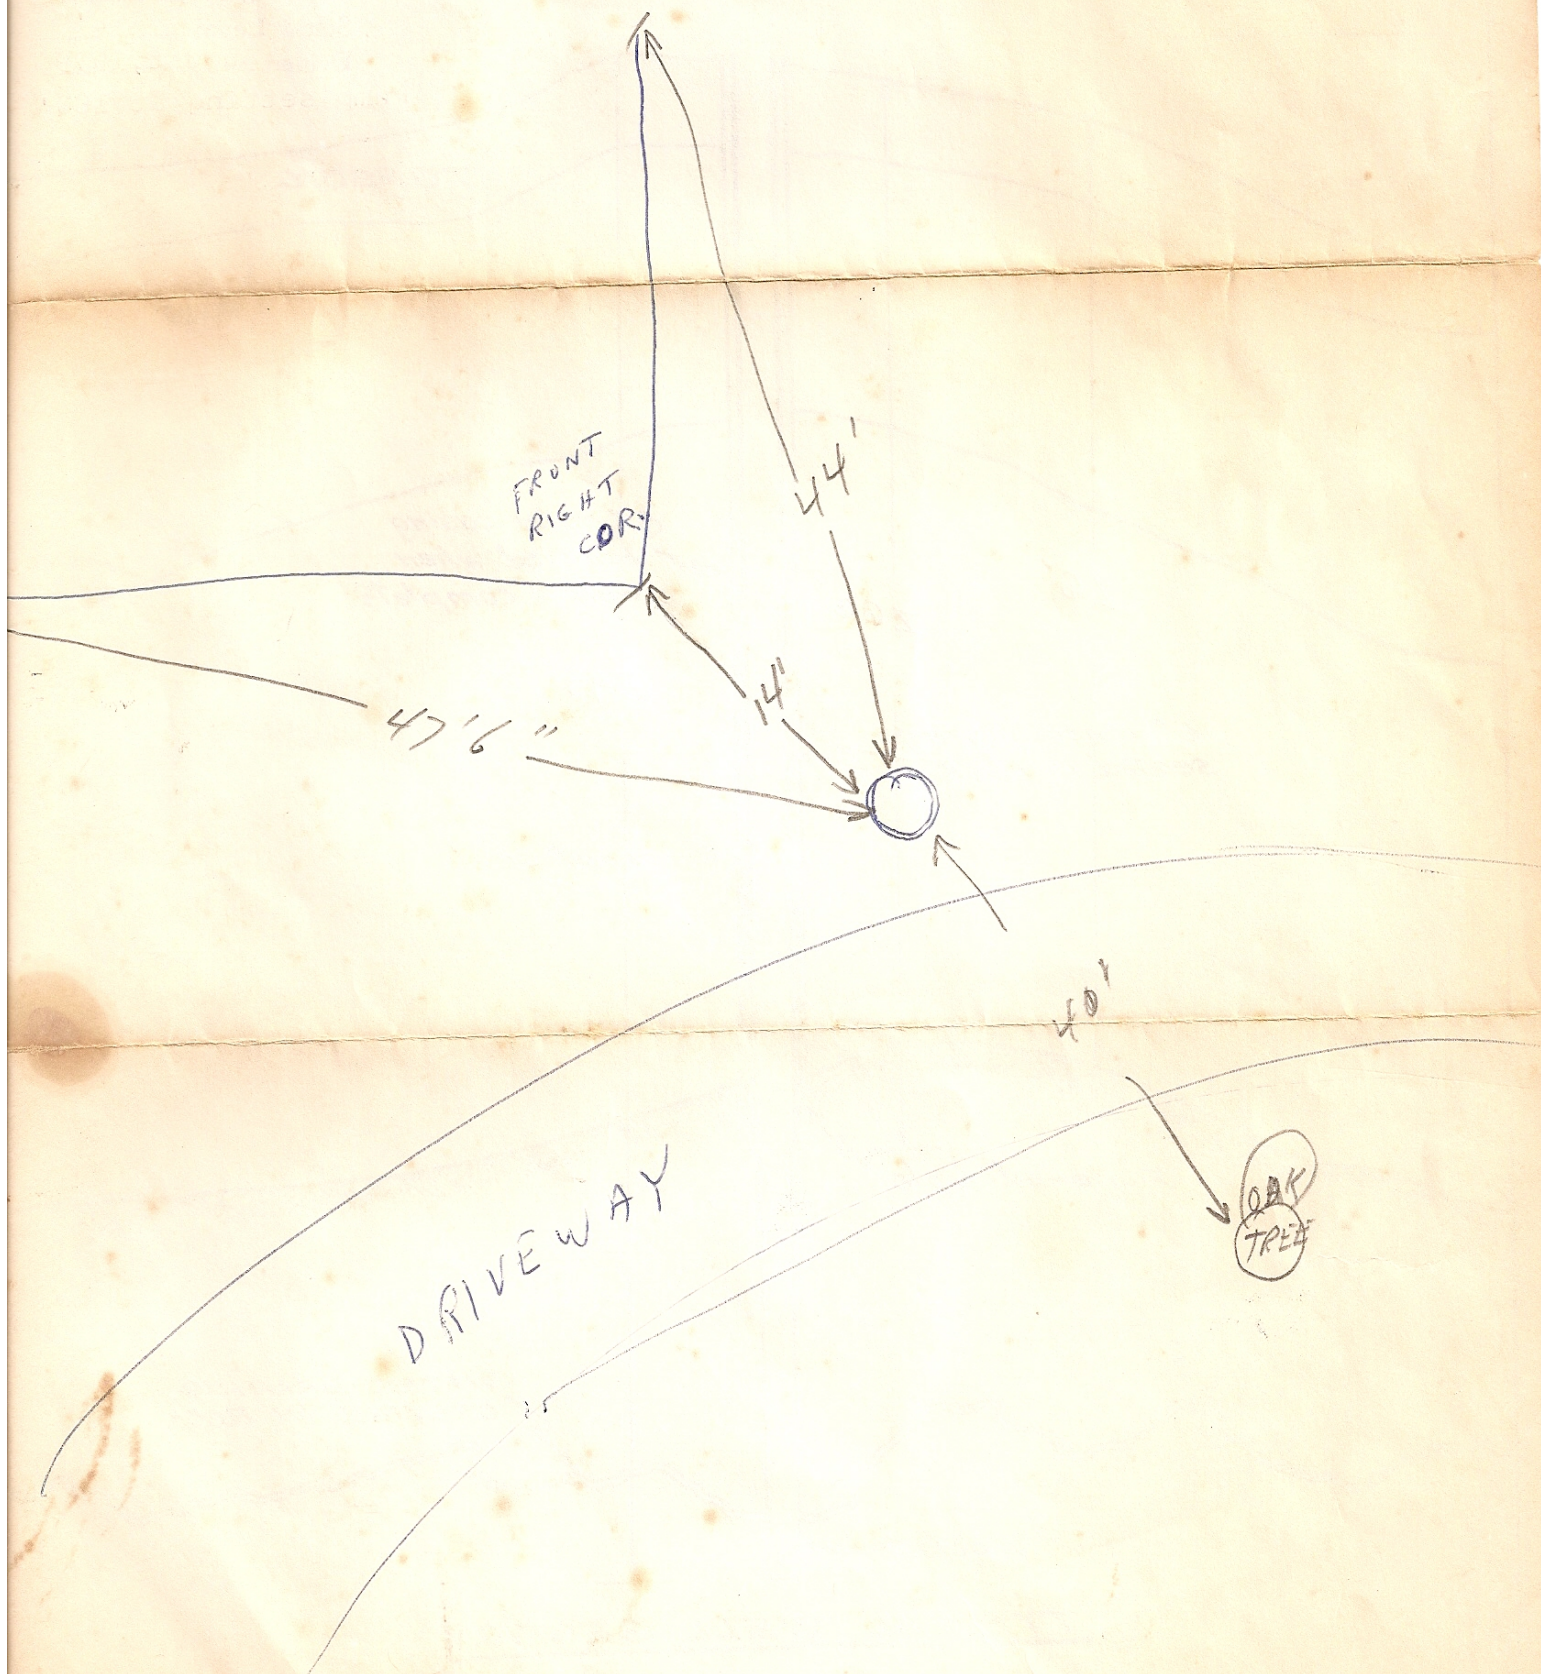
PRINT WITH NO SCALING
FOR 1"=10'
THIS IS A SKETCH !!!
EVERYTHING IS APPROXIMATE!!!

BOTTOM OF SLOPE
